**State of Louisiana  
Department of Natural Resources  
Coastal Restoration Division**

**2006 Annual Inspection Report**

**Barataria Bay Waterway West  
Bank Protection**

State Project Number BA-23  
Priority Project List 4

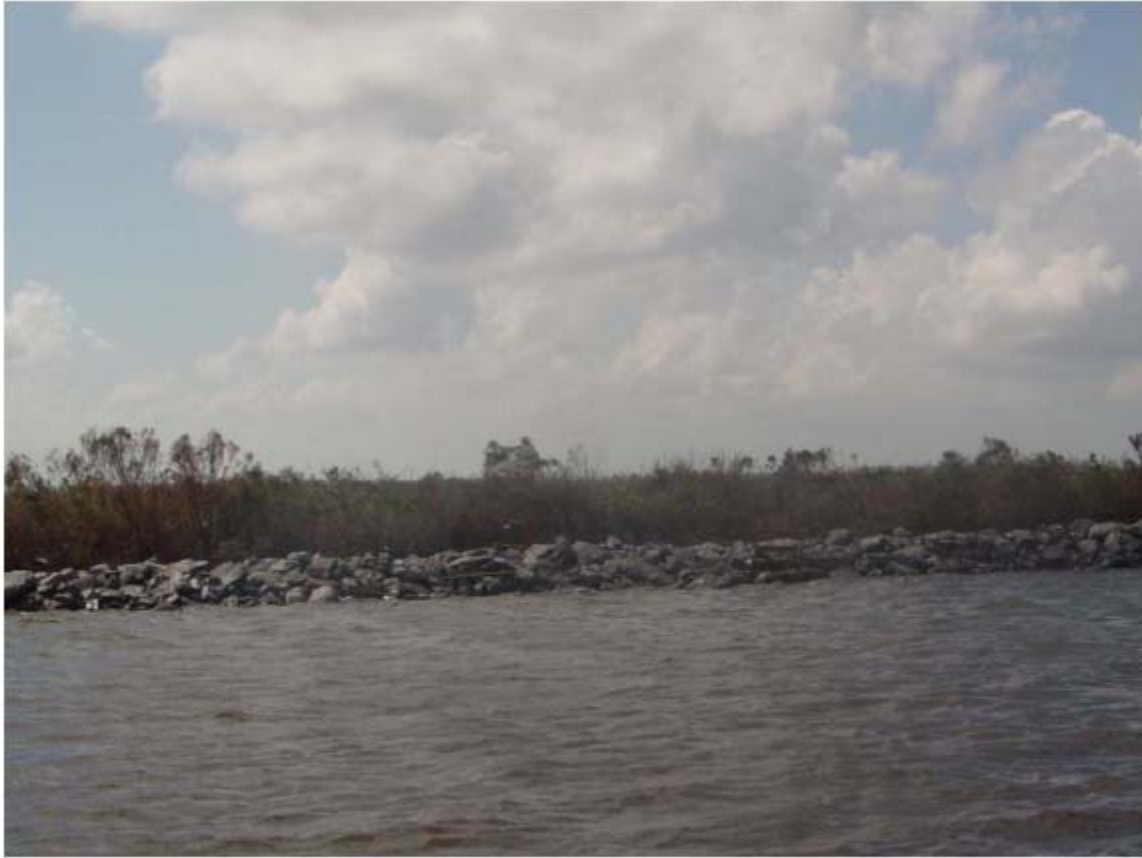
There was no noticeable damage to the rock structure due to the Hurricanes Katrina and/or Rita. Prior to the Hurricane there was some settlement noticed in the structure which was still present at the time of the inspection (Photo #1). In December, 2005, a contract to raise these structures was awarded and resulted in the placement of 5,143 tons of rock riprap on the settled sections of the structure. The work was completed on January 24, 2006 (Photo #2).

**Photo #1 – Shoreline Protection.** Before Maintenance Project.

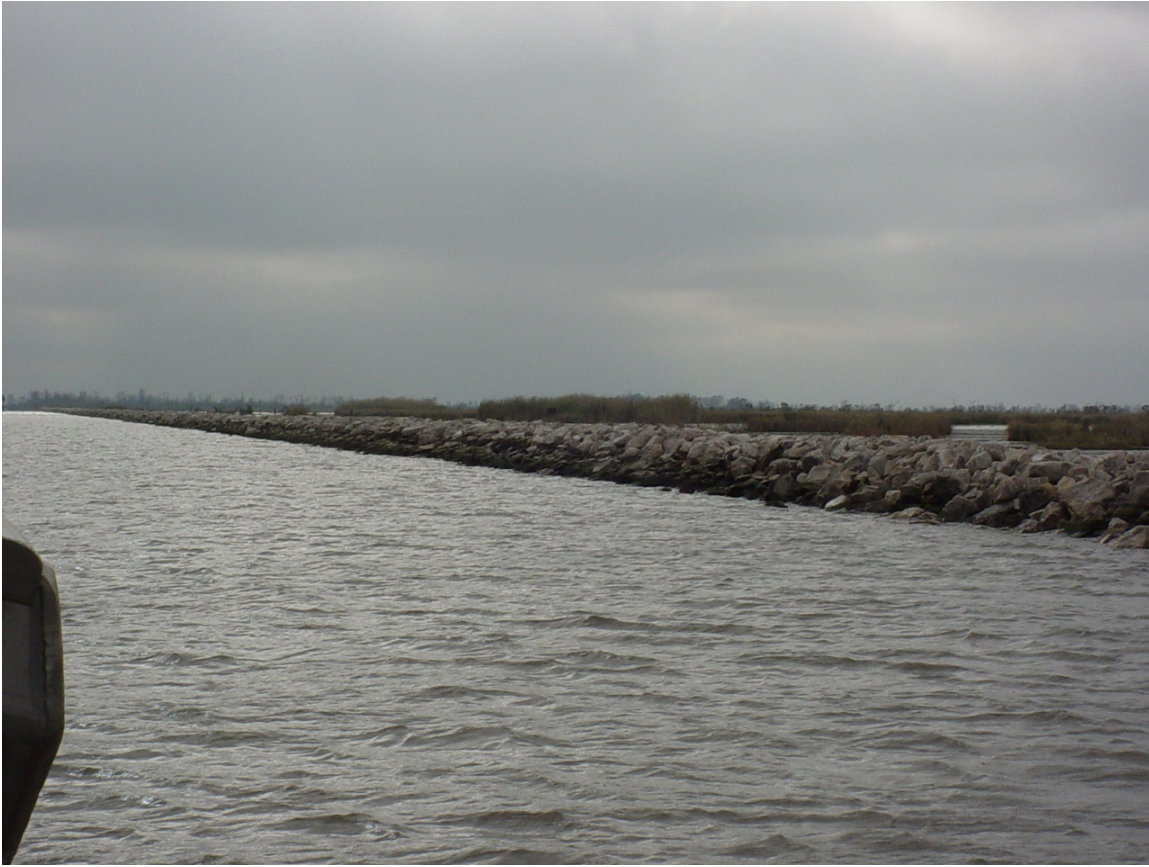
**Photo #2 – Shoreline Protection.** After Maintenance Project.

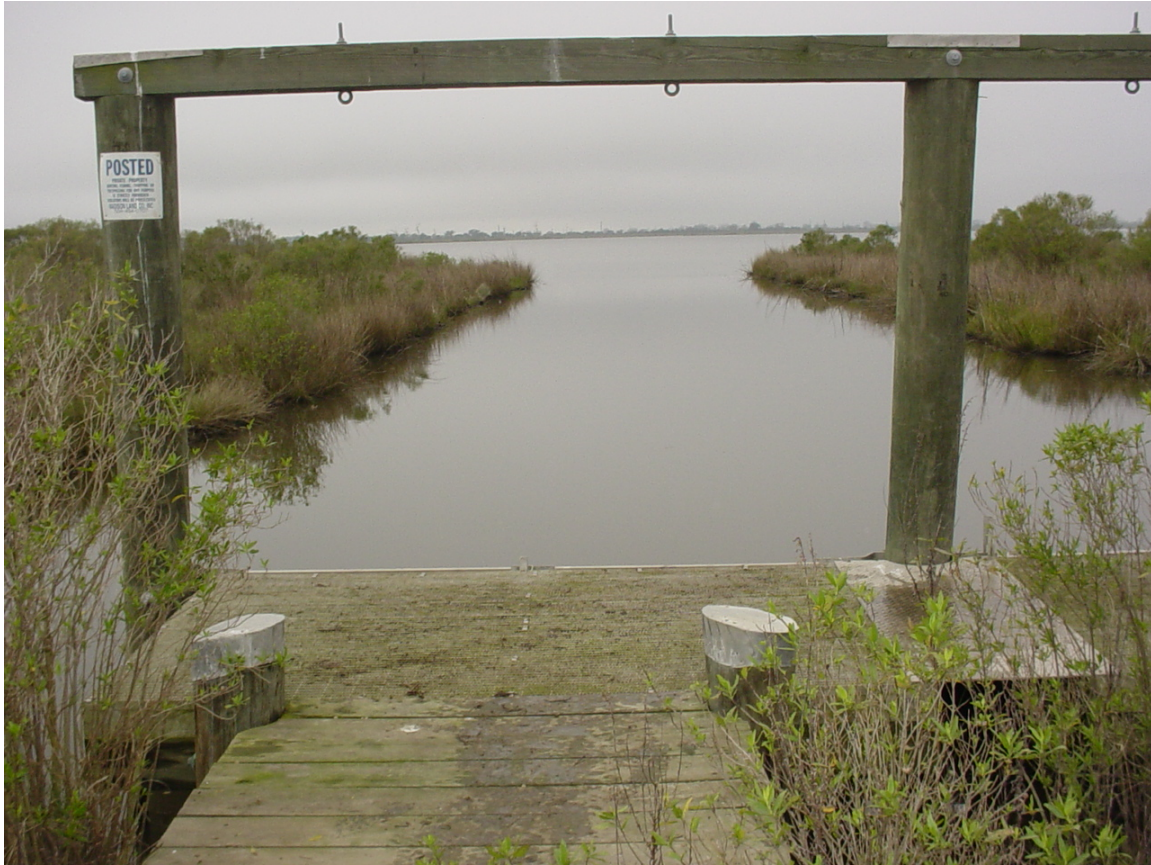
The water control structure showed no signs of damage due to the Hurricane (Photo #3). The structure was flowing water from the BBW into the wetlands. The stop-logs for the structure were out at the time of inspection as per the current permit requirements. The stop logs were placed in the stop log bays on November 30, 2005, and were removed on February 22, 2006.

**Photo #3 – Water Control Structure.** Stop logs are out of the bays.
